APOLLO 17

30-DAY FAILURE AND ANOMALY LISTING REPORT

APOLLO 17
30-DAY FAILURE AND ANOMALY LISTING REPORT

PREPARED BY
Mission Evaluation Team

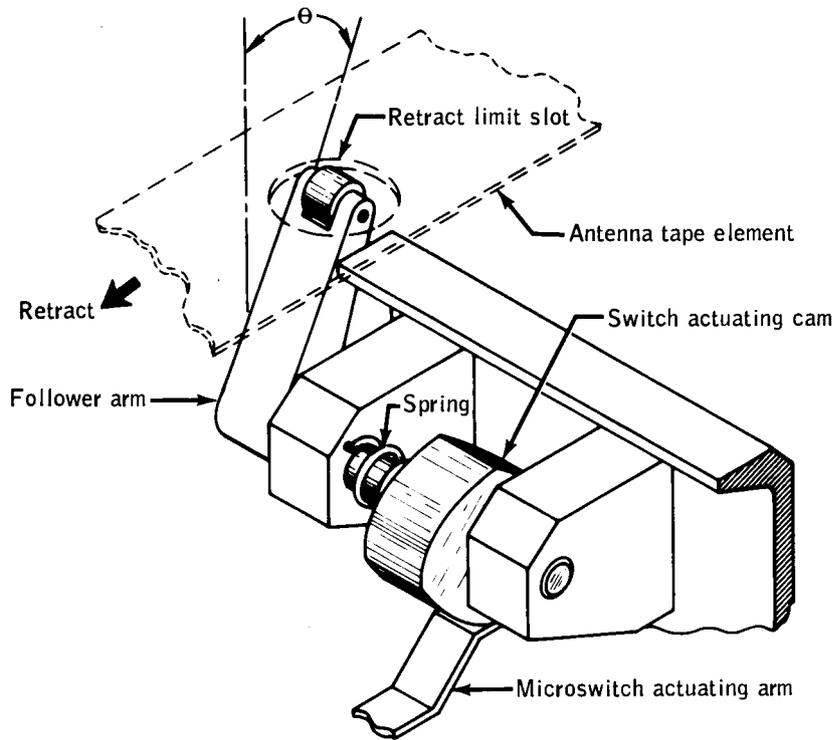
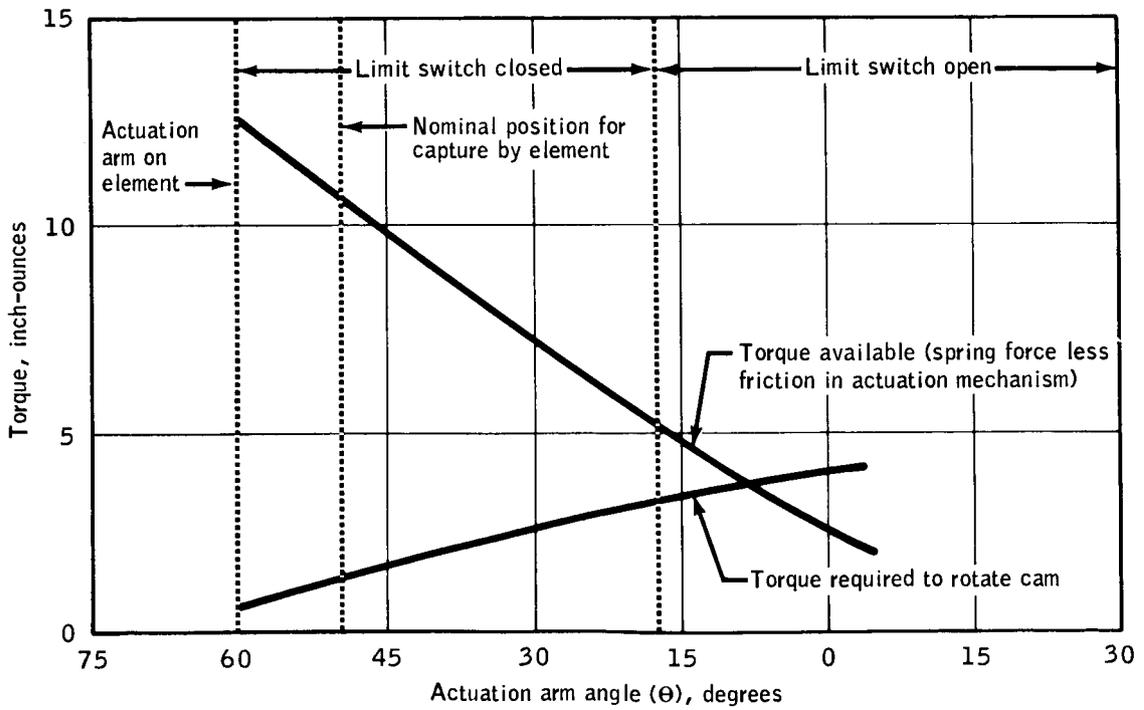
Figure 2-1.- Limit switch.

The retract limit sensing switch on HF antenna boom 1 failed to operate, resulting in telemetry and command module display data that indicated the boom had not fully retracted.

Current data indicated that the antenna did fully retract; i.e., that the motor stalled after retracting for a nominal period. This verified the antenna motor/gear box/retractor mechanism was satisfactory and isolated the problem to the retract limit switch and its actuating mechanism. Possible failure modes of this device include the following:

- a. Friction or a defective spring on the limit switch cam follower arm.
- b. Misalignment (or indexing) of the cam follower arm with the hole in the element.
- c. Limit switch (microswitch) assembly malfunction.

Figure 2-1 shows the torque available in the spring and the torque required to rotate the cam. At the nominal position angle for capture by the element, there is a positive margin of 8 to 1. Therefore, increased friction is not considered a possible cause. The remaining failure modes have been investigated without establishing a most likely cause. However, since this device is not to be flown on future missions, no further action is required.

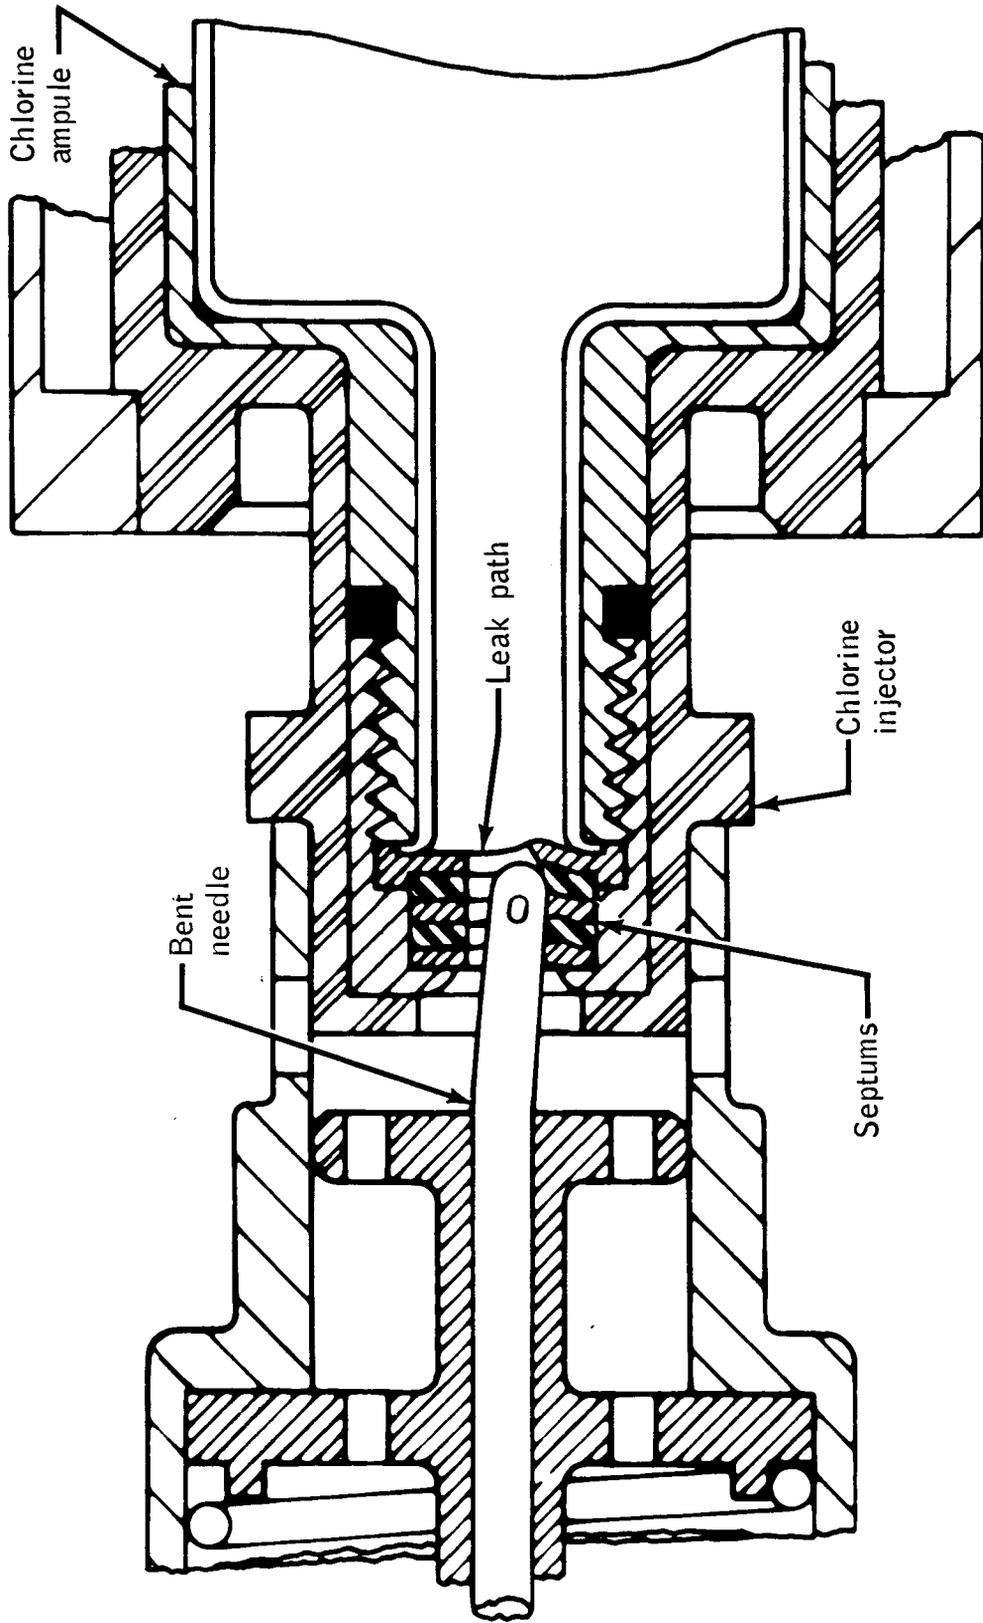
Figure 2-2.- Chlorine leak failure.

A total of 13 chlorine ampules and 13 buffer ampules were used during the mission. Postflight testing showed that six of the expended chlorine ampules and five of the expended buffer ampules had bladder leaks. In four of these eleven ampules, the bladders were extruded past the baseplate.

Examination showed that the outer needle of the injector needle assembly was bent and possibly formed a leakage path when penetrating the ampule grommets at an angle (fig. 2-2). During postflight testing, three injections were accomplished with no leaks caused by the bent needle. Additional postflight examination of the ampules and injector system is presently in progress.

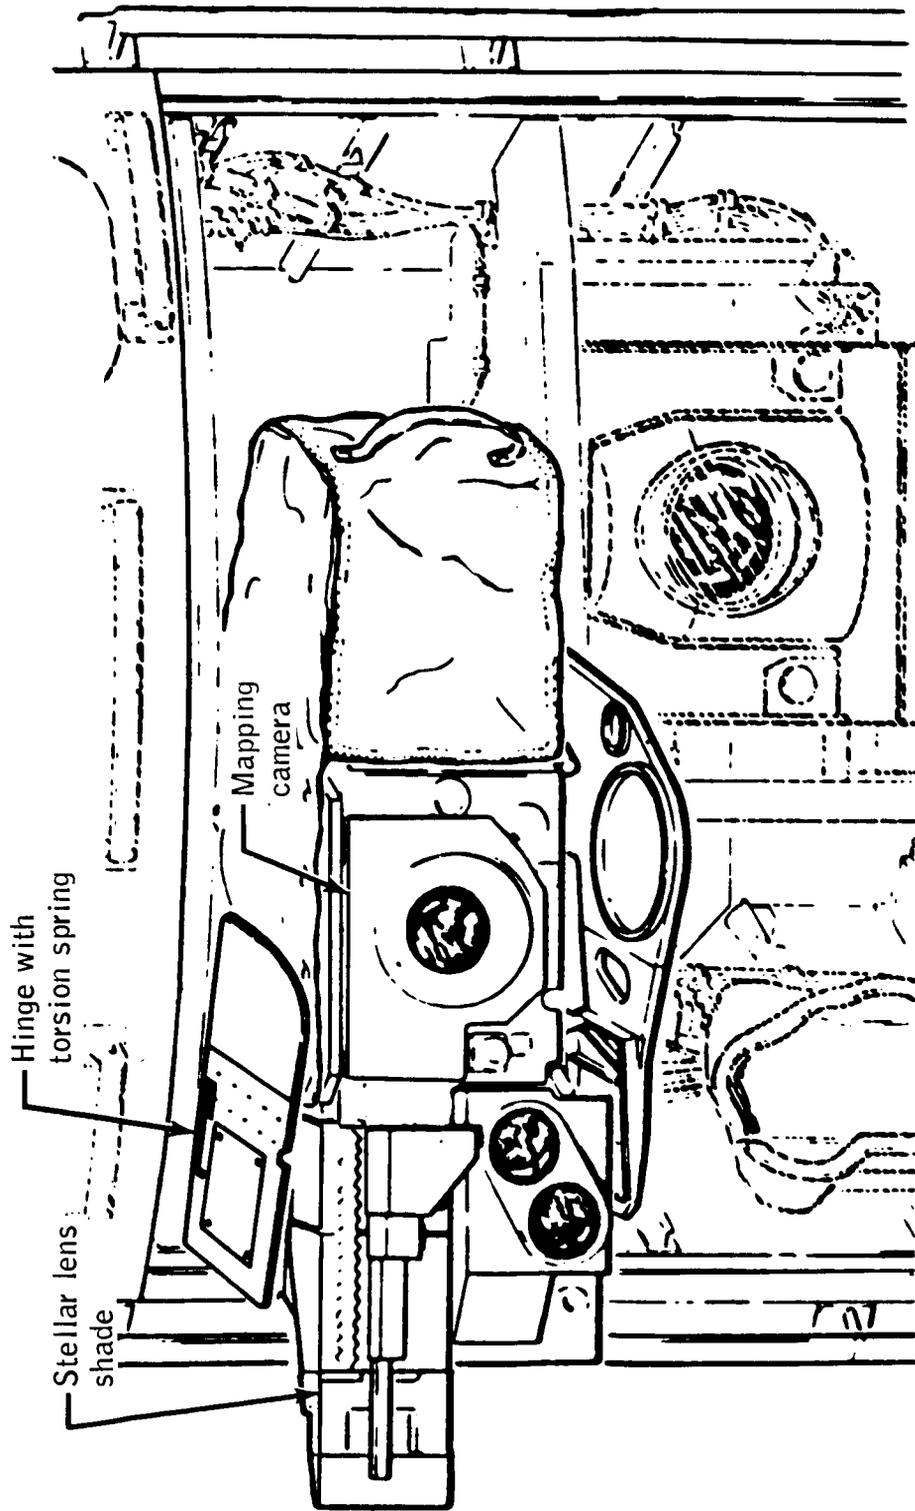
Figure 2-3.- Reaction control system plume shield door.

Photographic data taken from the lunar module during rendezvous shows the mapping camera reaction control system plume shield door in the open position with the mapping camera apparently retracted.

The door is attached to the spacecraft with a hinge that includes a torsion spring to close the door when the camera is retracted (fig. 2-3). The door is pushed open by the camera when it is deployed. The photographs show the camera to be fully retracted which indicates that the problem is with the door itself.

Other mechanical systems anomalies have occurred on Apollo 15, 16 and 17 which suggests a common factor which is as yet unknown. In all cases, some degree of sliding between metal surfaces was required, which is the case with the door hinge. It is therefore conceivable that the friction between these surfaces may have been significantly increased by the effects of the space environment, and these effects have not been duplicated in ground testing.

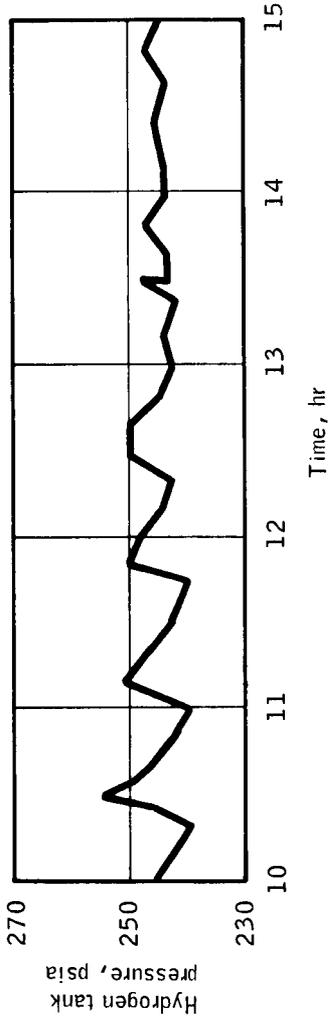
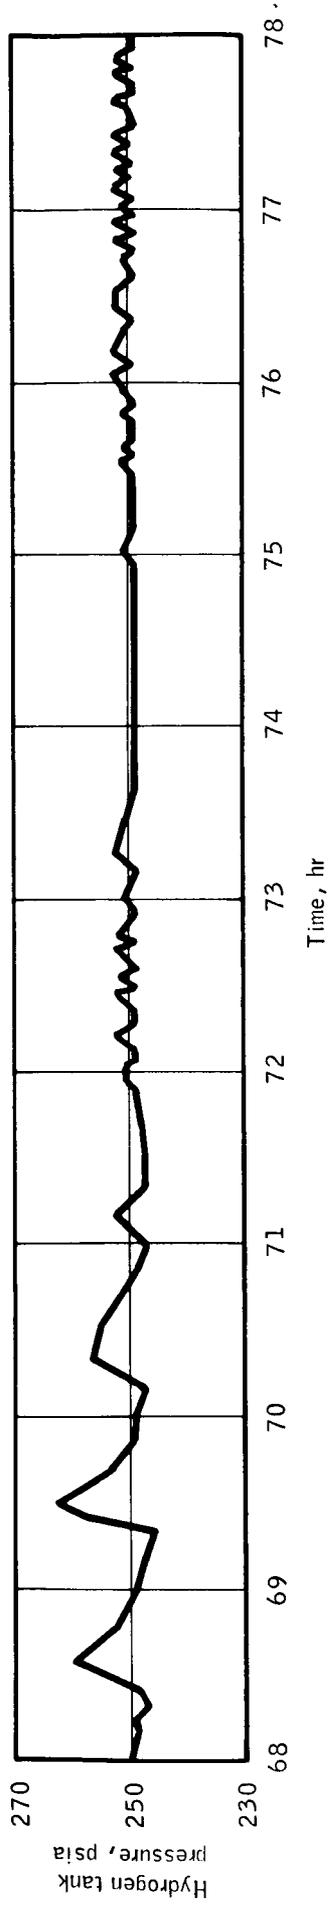
Figure 2-4.- System operating pressures during anomaly periods.

Cryogenic hydrogen system operation was normal until approximately 12 hours. The operating pressure range (deadband) after this time decreased from about 16 psi (238-254 psi) to approximately 3 psi (244-247 psi) by 13 hours (fig. 2-4) and continued in this mode until automatic heater operation for tanks 1 and 2 was terminated at about 15 hours. Automatic heater operation was resumed in tanks 1 and 2 at about 24 hours. Only about five automatic heater cycles (all normal) occurred in tanks 1 and 2 before approximately 71 hours because the fans were in the automatic mode in tank 3, and the tank 3 pressure switch controlled at a higher pressure than tanks 1 and 2. At that time, the tank 3 fans were turned off and the operating pressure deadband again decayed to 3 psi (248-251 psi) as shown in figure 2-4. This deadband was maintained until automatic heater operation was terminated in tanks 1 and 2 at 87 hours. Hydrogen system pressure was maintained for the remainder of the mission by use of manual fan operation in tanks 1 and 2 and automatic fan operation in tank 3. Hydrogen system operation was normal in this mode.

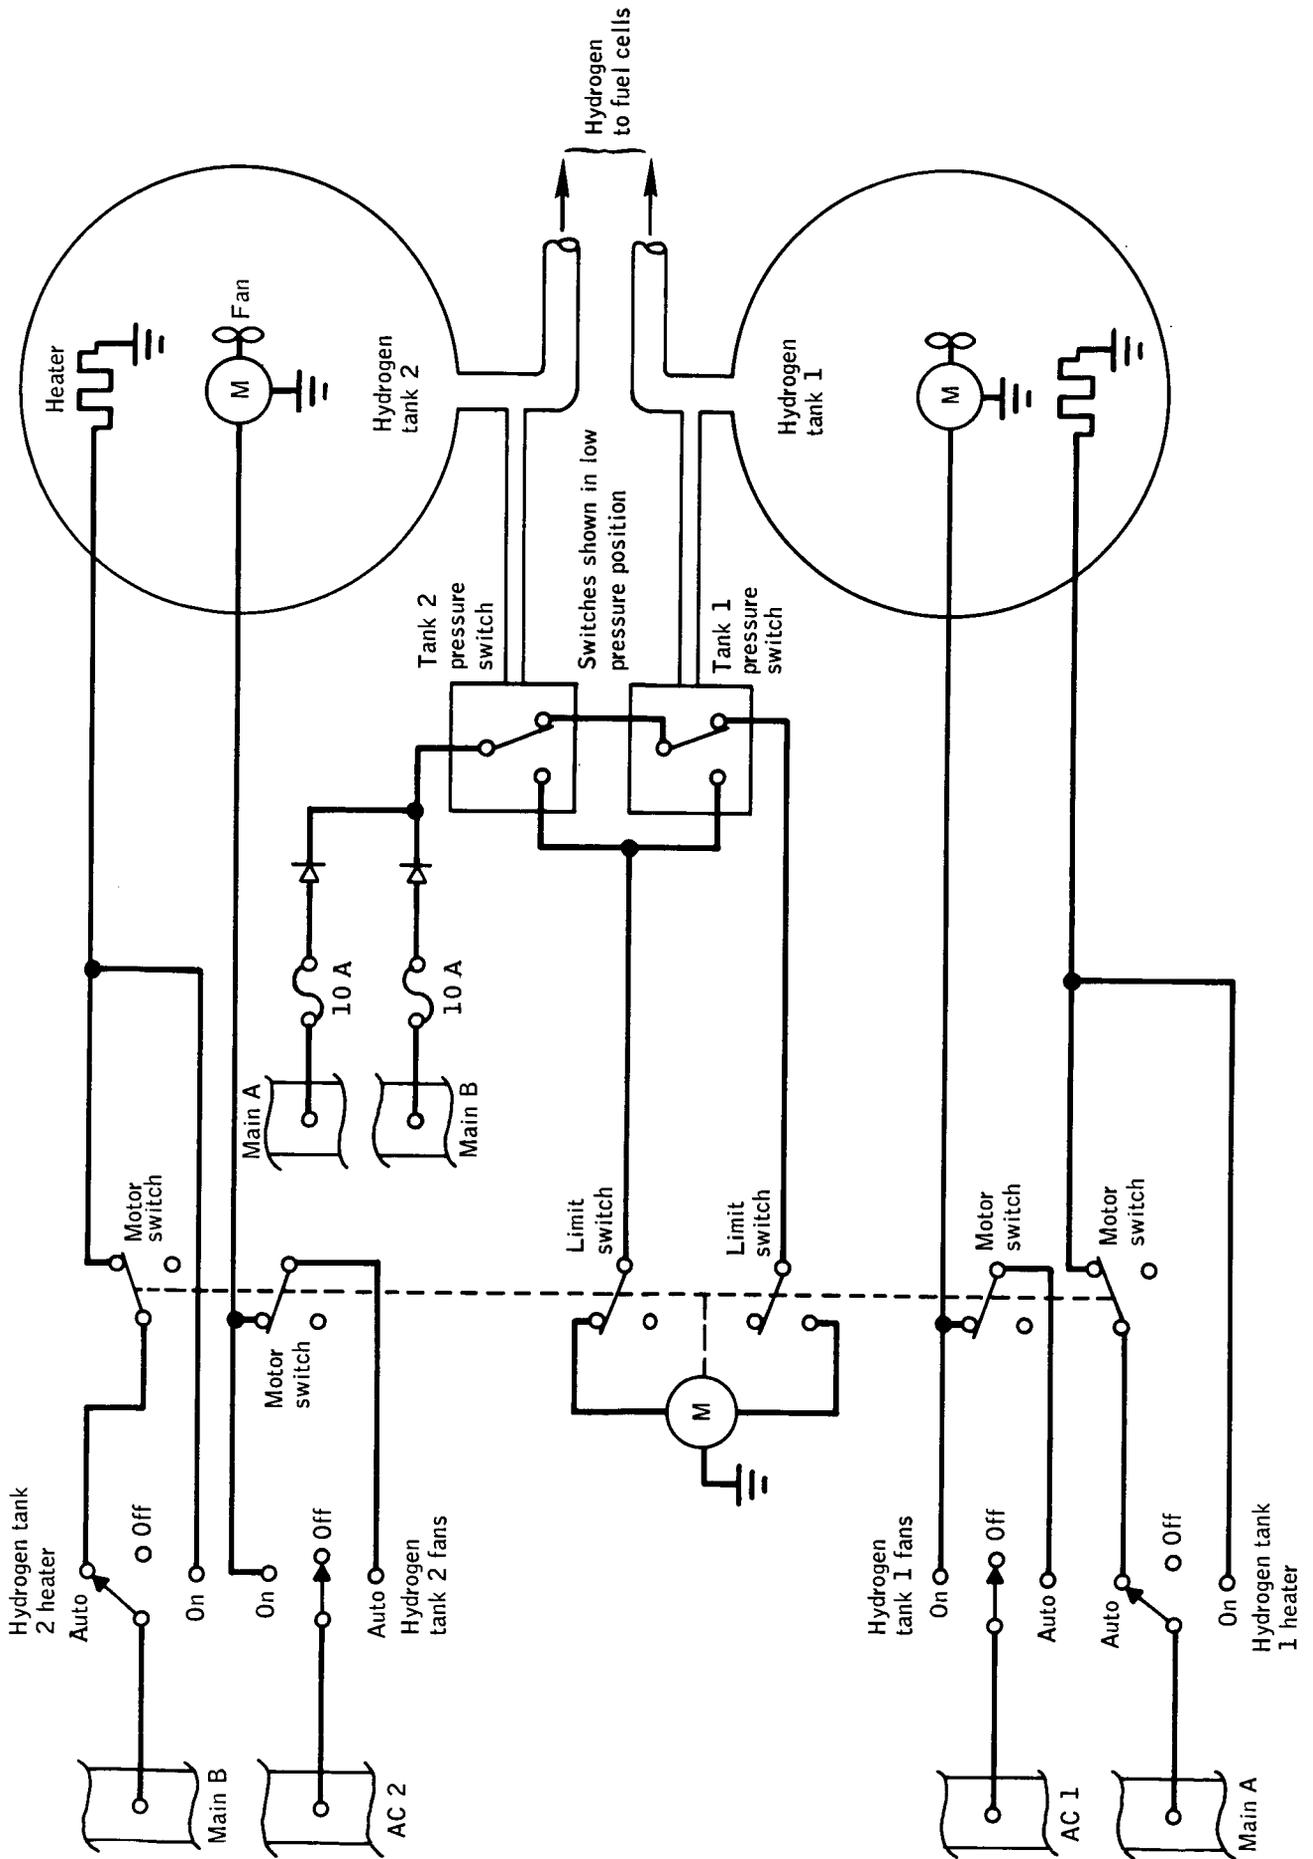
Figure 2-5.- Cryogenic system pressure control circuitry.

Individual pressure switches monitor pressures in tanks 1 and 2 as shown in figure 2-5. When automatic heater or fan operation is selected, both switches must be in the low-pressure position to apply power to the heaters or fans in each tank. When either switch transfers to the high pressure position, the motor switch transfers and removes power from the heaters and fans. Figure 2-6 is a cutaway sketch of one of the pressure switches in the low-pressure position.

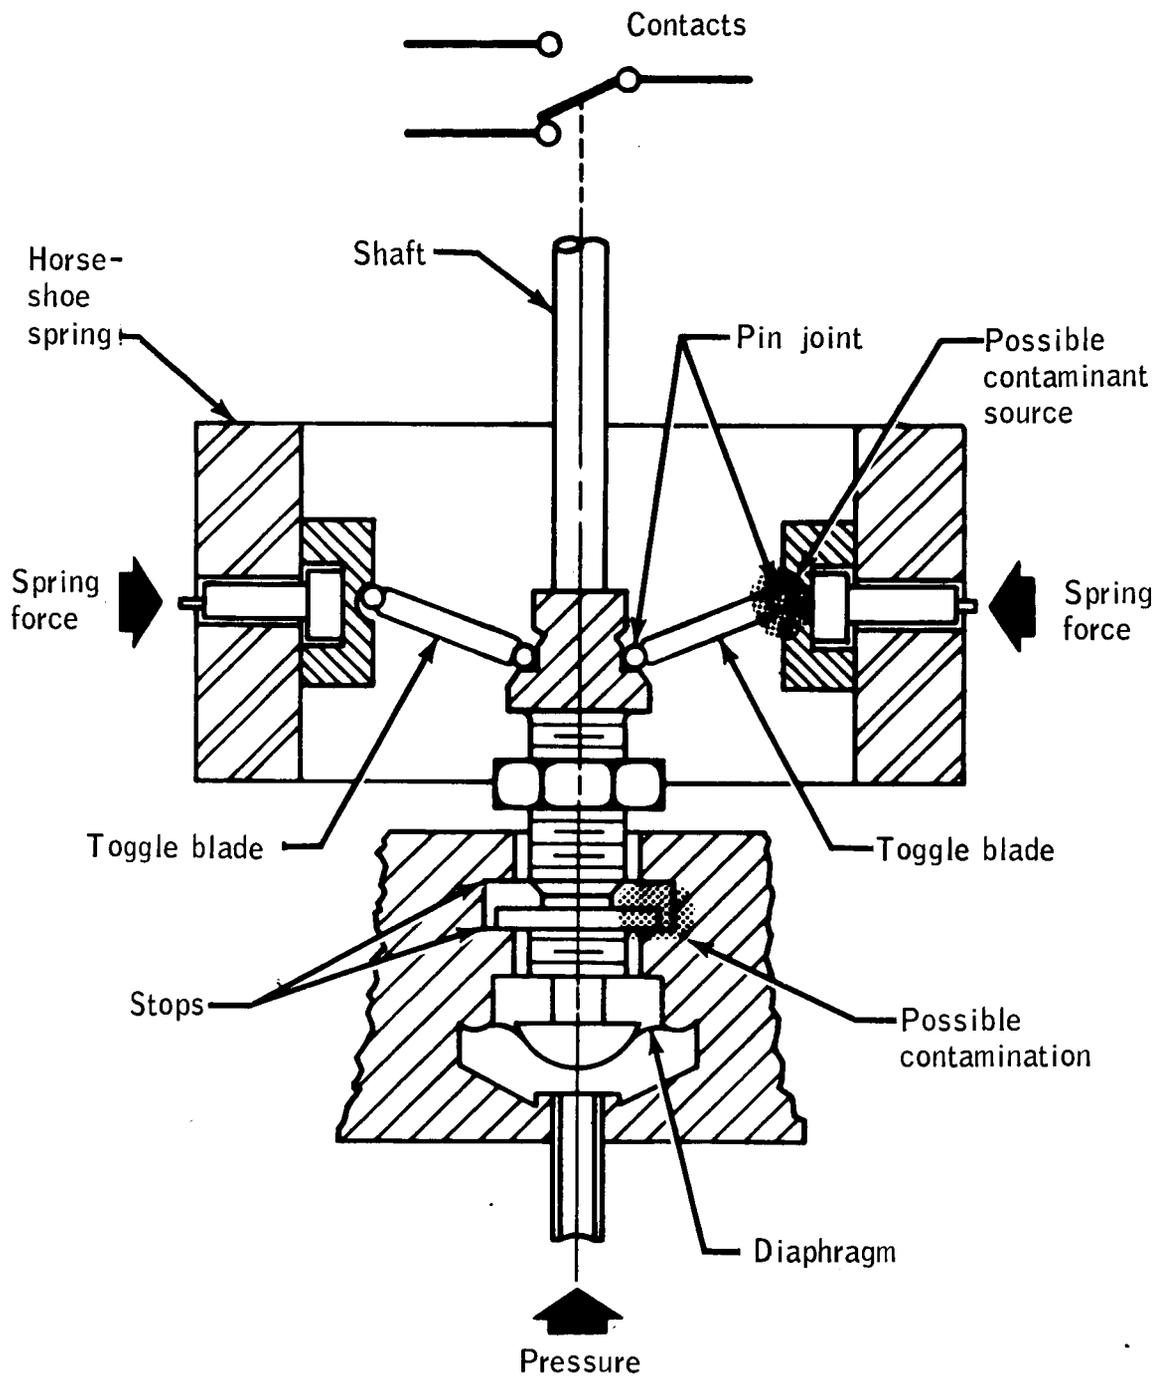
Figure 2-6.- Hydrogen tank pressure switch cutaway.

the pressure at which the shaft transfers to the lower position. Consequently, hard particles floating in the stop mechanism area shown in figure 2-6 can have a variable effect which can appear and disappear depending on the location of the floating particles.

The size of the particles required to change the pressure settings is relatively small. The full travel of the stop may be as small as 0.007 inch. The pressure change to move from one stop to the other is about 15 psi. Consequently, the upper limit can be reduced to about 7 psi with a piece of metal about 0.004-inch in size between the stop on the shaft and the upper case stop.

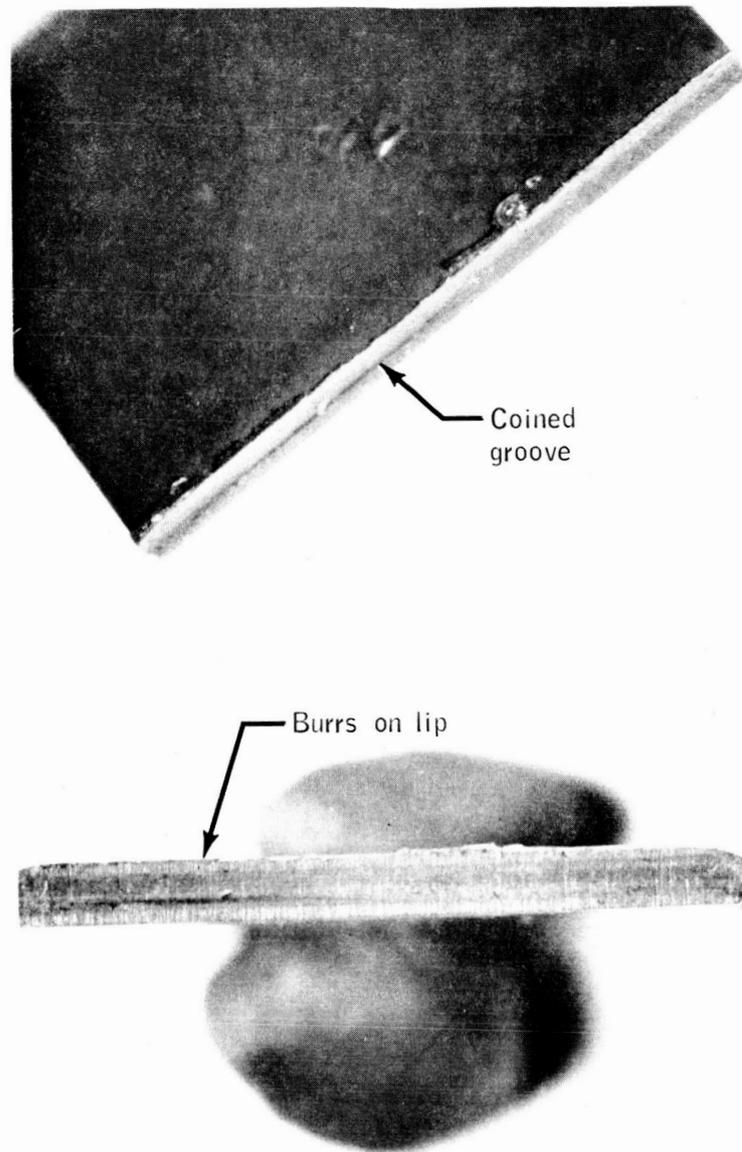
Figure 2-7.- Pressure switch toggle plate.

The toggle plates are pin-joined to the shaft at one end and to a horseshoe-shaped spring at the other end as shown in figure 2-6. Grooves are formed in the opposite edges of the toggle plates by a coining operation. Figure 2-7 shows the toggle plate taken from a switch which was disassembled for inspection. In this instance, burrs were found that were about to break off. The particles could then move around and become trapped in the stops under zero-gravity conditions.

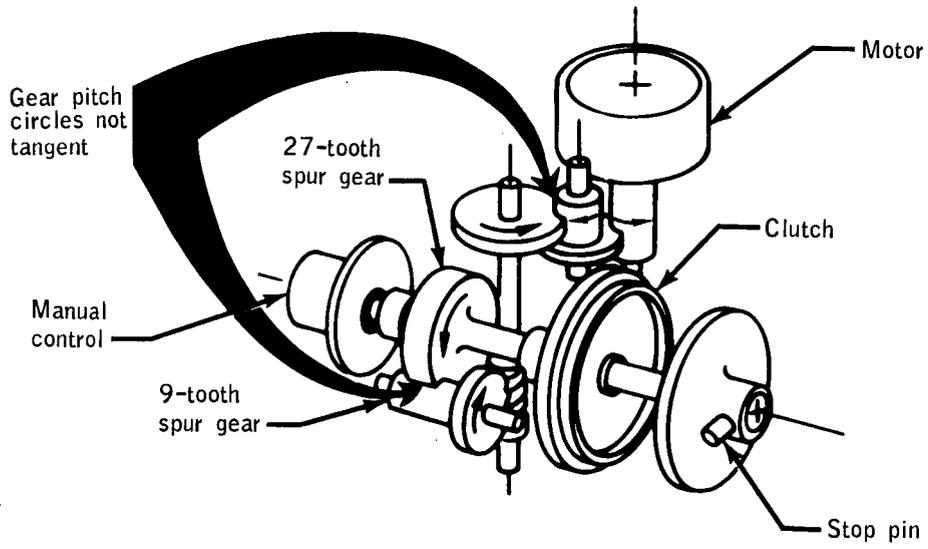
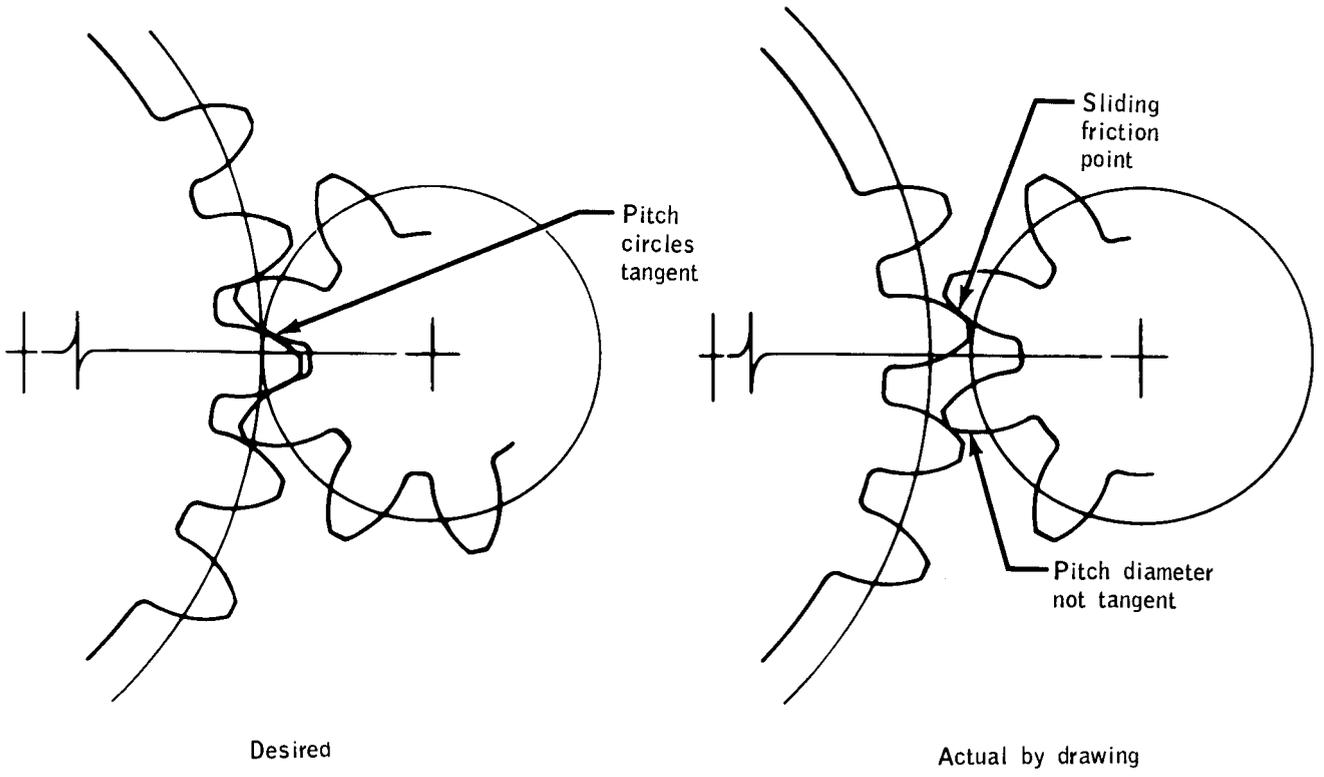
Figure 2-8.- Water/glycol temperature control valve gear drive.

Dimensional checks have shown that the pitch circles of two of the gear pairs in the valve gear train are not tangent (fig. 2-8). This results in sliding rather than rolling action between contacting teeth. One valve which previously experienced the same sticking has been disassembled and the gears showed no abnormal wear, although the dry lubricant was scraped off the gear teeth in the area of tooth-to-tooth contact. Sliding friction between the unlubricated gear teeth may have been high enough to cause the sticking experienced.

Since manual valve operation is satisfactory for future missions, no further action will be taken.

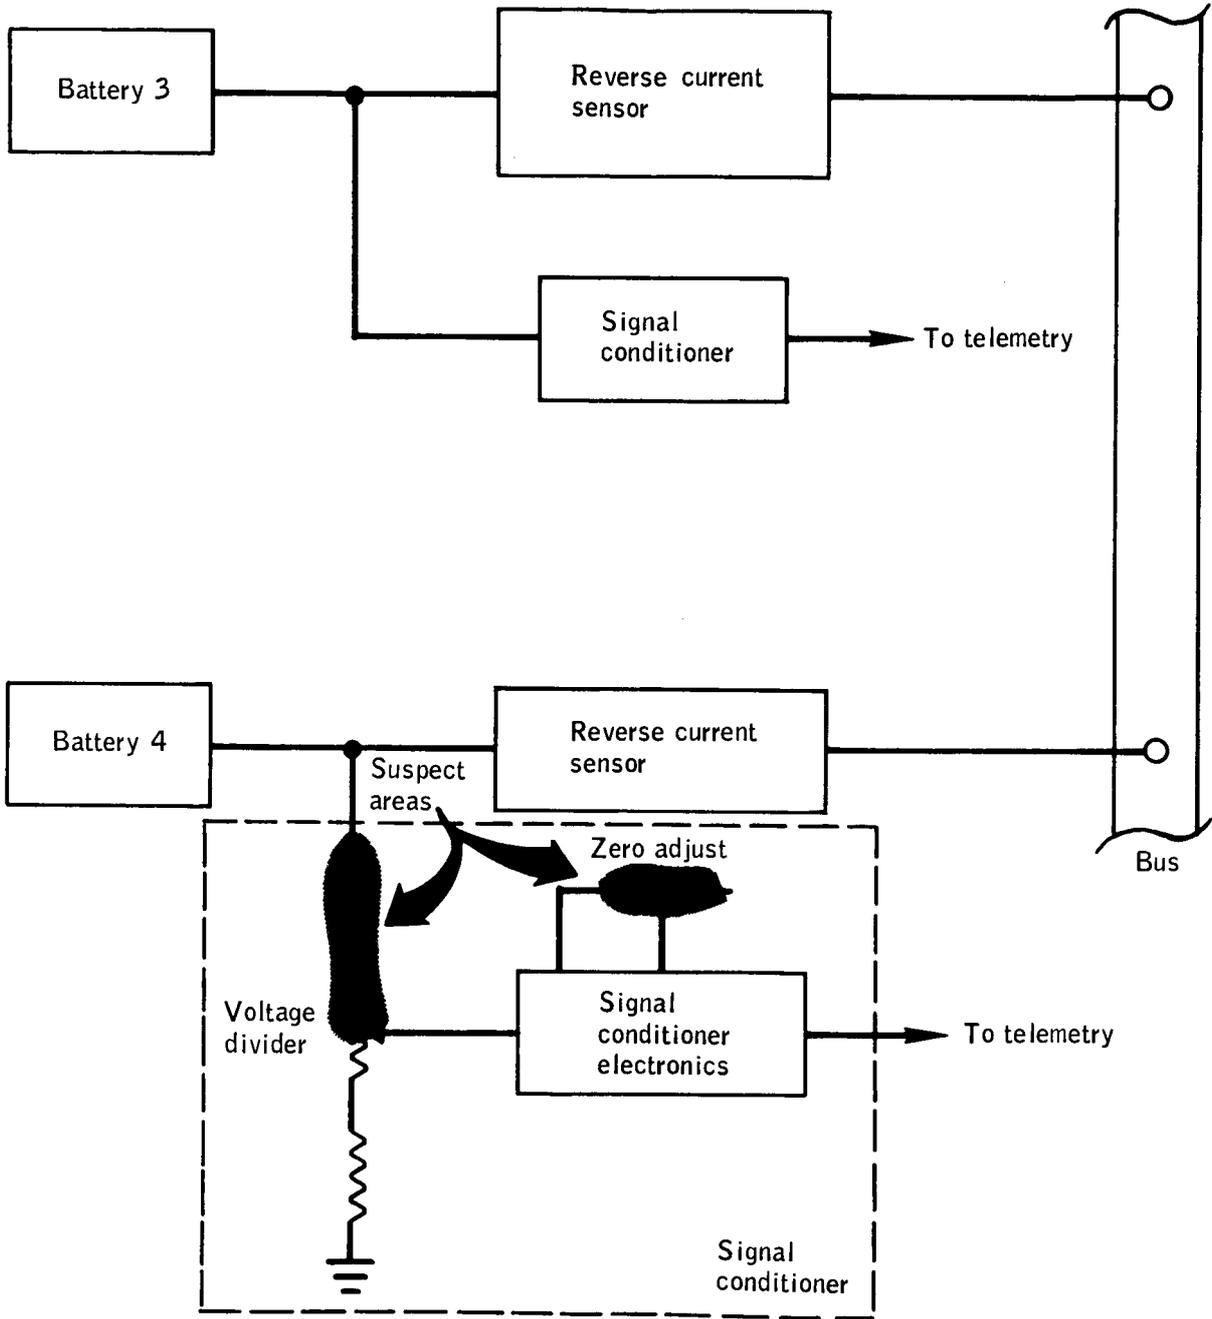
Figure 3-1.- Voltage measurement circuitry.

The battery 4 voltage measurement is conditioned by a signal conditioner which consists of an input resistive divider network feeding a dc-to-dc converter (fig. 3-1). An increase of resistance of 1 percent in this network can account for the observed change. Another possibility of failure exists in the zero-adjust network.

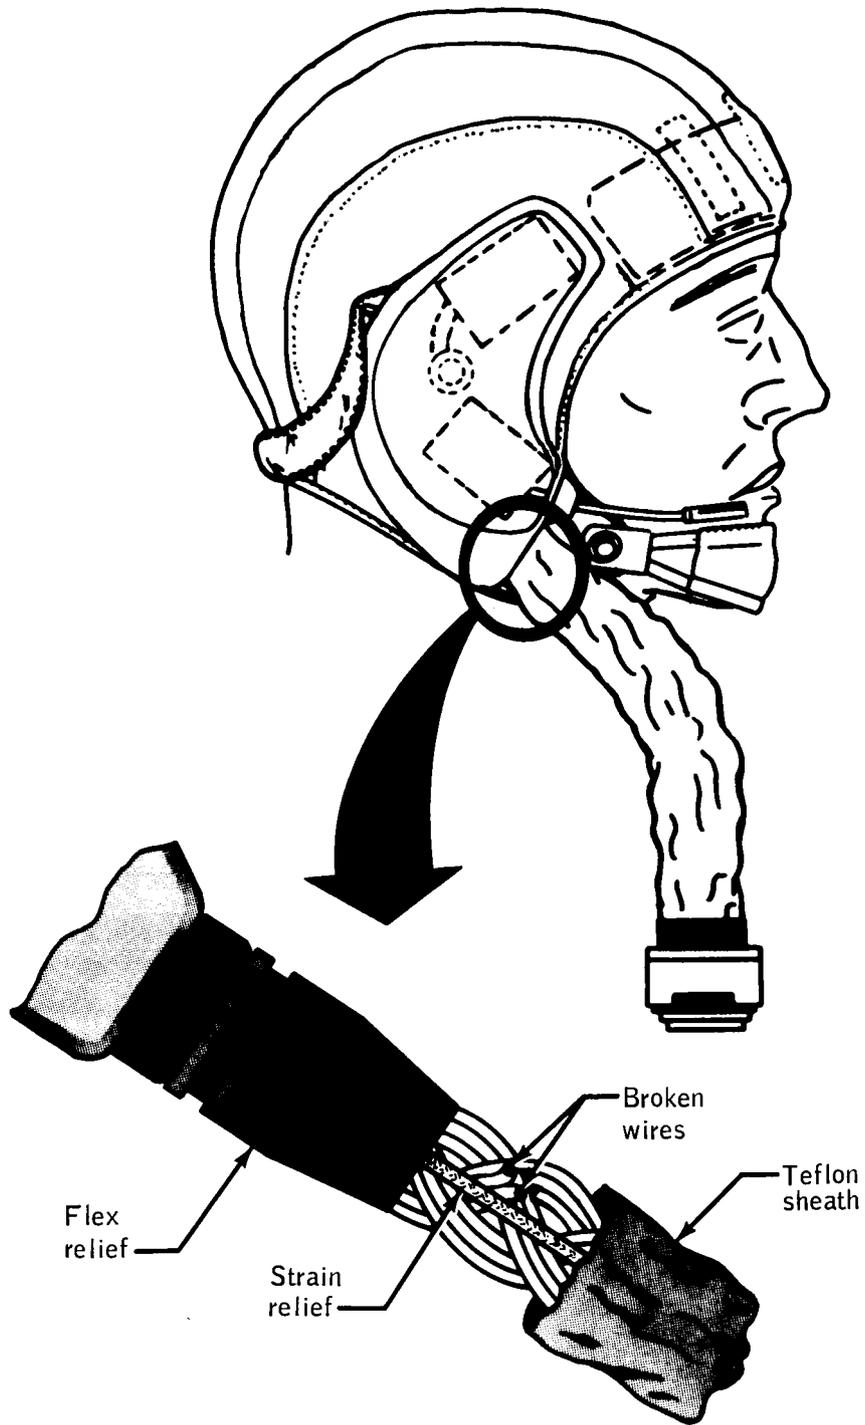
Figure 4-1.- Communications carrier wire failures.

After the extravehicular activity, the Command Module Pilot partially removed the sleeve covering his communications carrier electrical pigtail and found that of the nine leads (twisted shielded pairs) making up the pigtails, two were broken (fig. 4-1).

Failure analysis of the returned flight item has shown that the failed wires were broken about 1/4 inch below their exit point from the potting of the flex relief attached to the lower end of the communications carrier splice block. The break occurred where these wires lay across an adjacent set of wires in a braided configuration. The functions carried by these wires were caution/warning tone and left earphone circuits.

Repeated twisting and knotting of similar wire bundles to the extent described by the crewman has demonstrated that the point of breakage was inherently the most highly loaded due to the geometry of the pigtail, and thereby was subject to flex/tensile failure.

Skylab training and flight procedures are being revised to reflect a harness configuration that prevents the twisting of the wire harness.

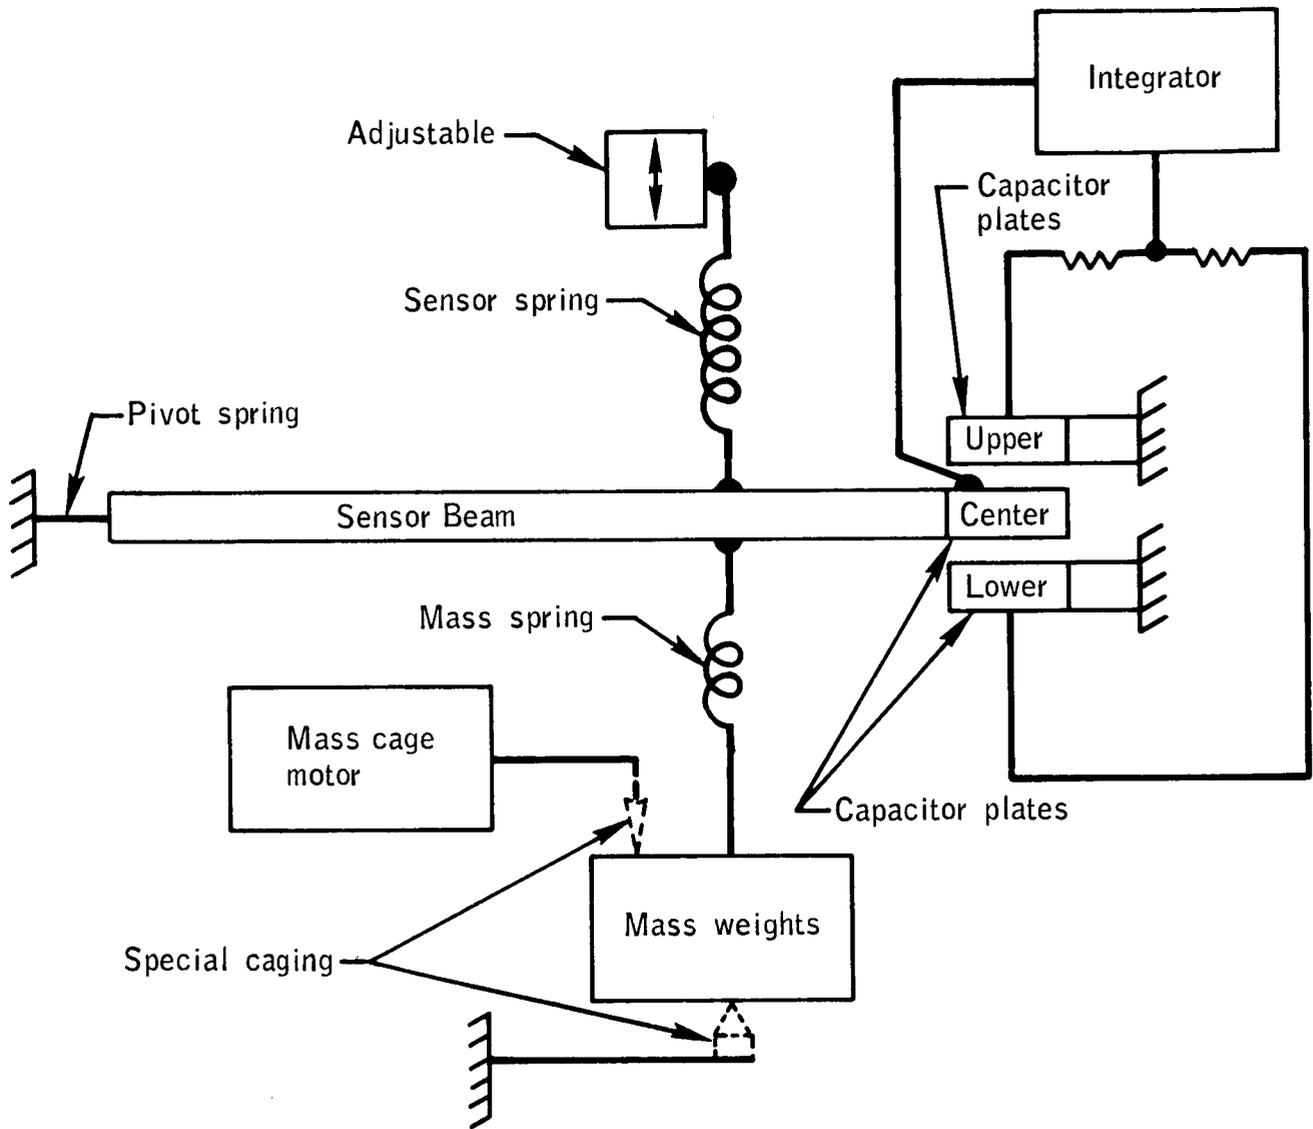
Figure 5-1.- Lunar surface gravimeter sensor beam centering.

Centering the sensor beam capacitor plate in the proper stable position between the fixed capacitor plates (fig. 5-1) could not be accomplished following the initial experiment turn-on. When the command was given to add any or all of the masses to the sensor beam assembly, the data indicated that the beam would not move away from the upper capacitor plate. The only way to bring the beam down was by caging it against the lower capacitor plate.

Review of sensor records revealed that a mathematical error resulted in the sensor mass weights being about 2 percent lighter than the proper nominal weight for 1/6-g operation of the flight unit. The sensor mechanism allows up to only ± 1.5 percent adjustment from the nominal by ground command for possible inaccuracies. The error was made in the conversion calculations from 1-g to 1/6-g mass for the flight unit by including an erroneous value in the calculations from the uncorrected calculations for the qualification unit.

Because the mass weights do not provide enough downward force, the beam has been balanced and centered by applying a load on the beam through the mass support springs. This is accomplished by special caging of the mass weight assembly with ground commands to the mass cage motor as shown in figure 5-1. In this configuration, the mass spring permits balance of the beam and function of the instrument. However, the spring constant of the mass spring considerably reduces the sensitivity of the system.

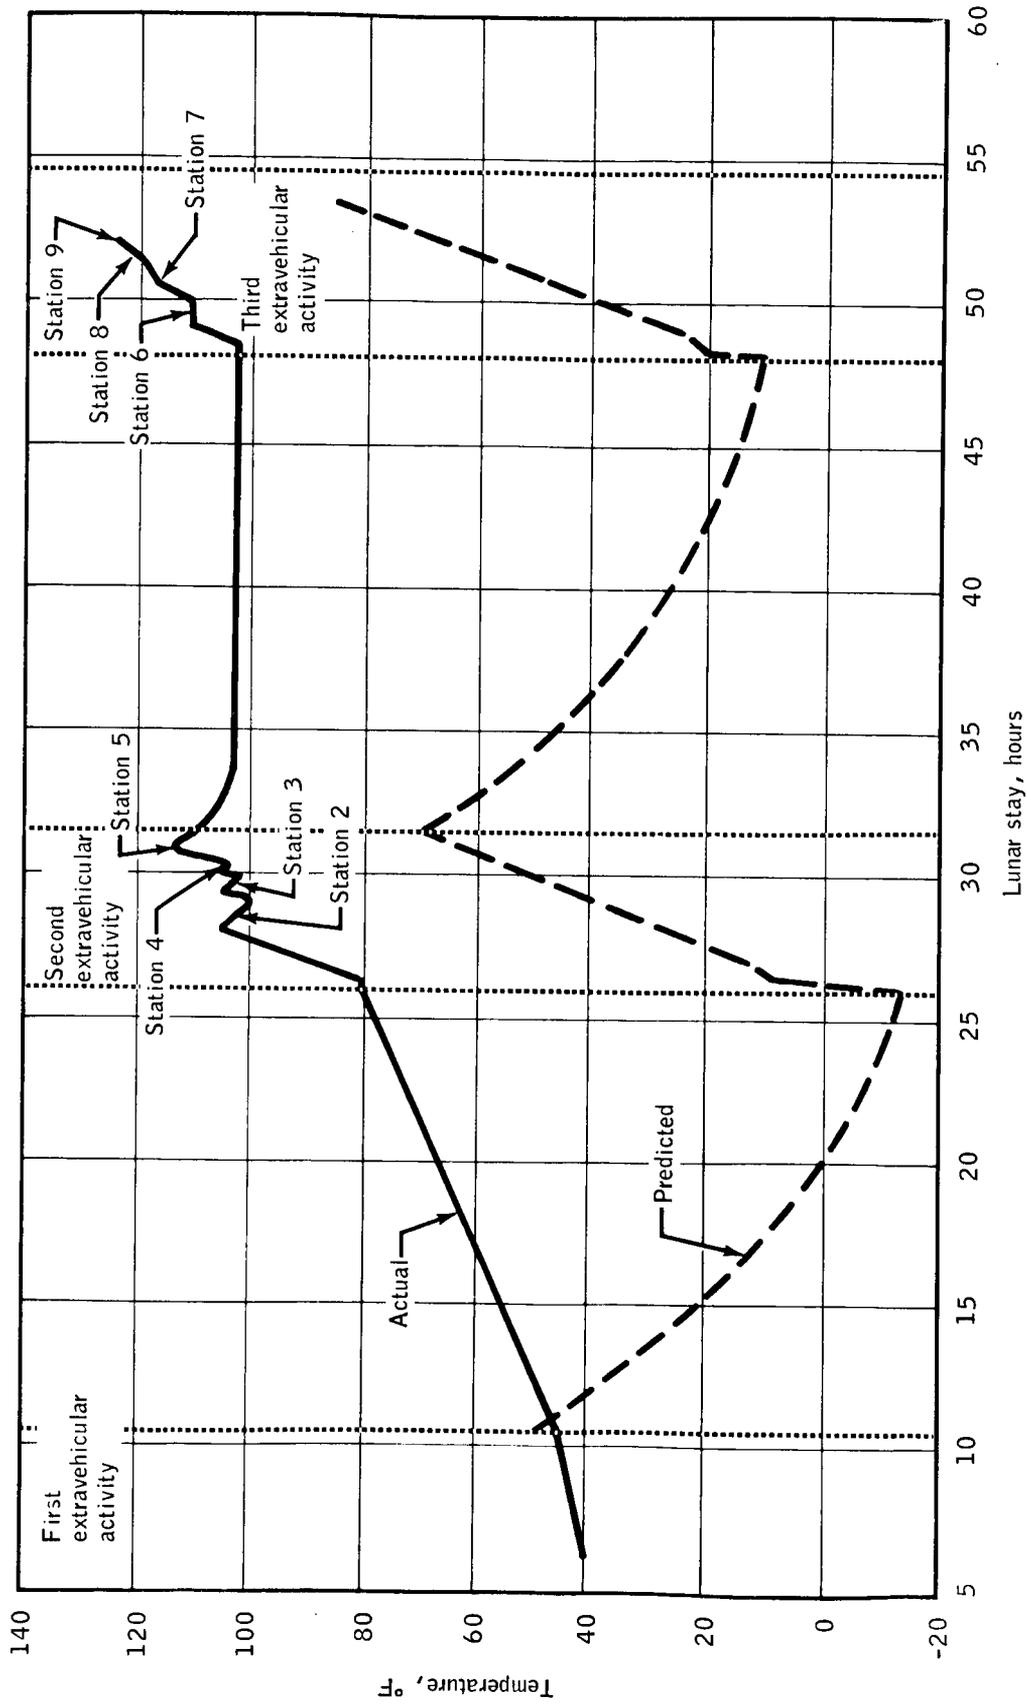
Figure 5-2.- Surface electrical properties experiment receiver temperature data.

The receiver temperature was about 5° F less than normal at the end of the first extravehicular activity as shown in figure 5-2. However, during the rest period between the first and second extravehicular activities, the temperature rose to 80° F instead of dropping to about minus 14° F as predicted. Between the second and third extravehicular activities, the temperature dropped about 8° F instead of the expected drop of about 50° to 60° F.

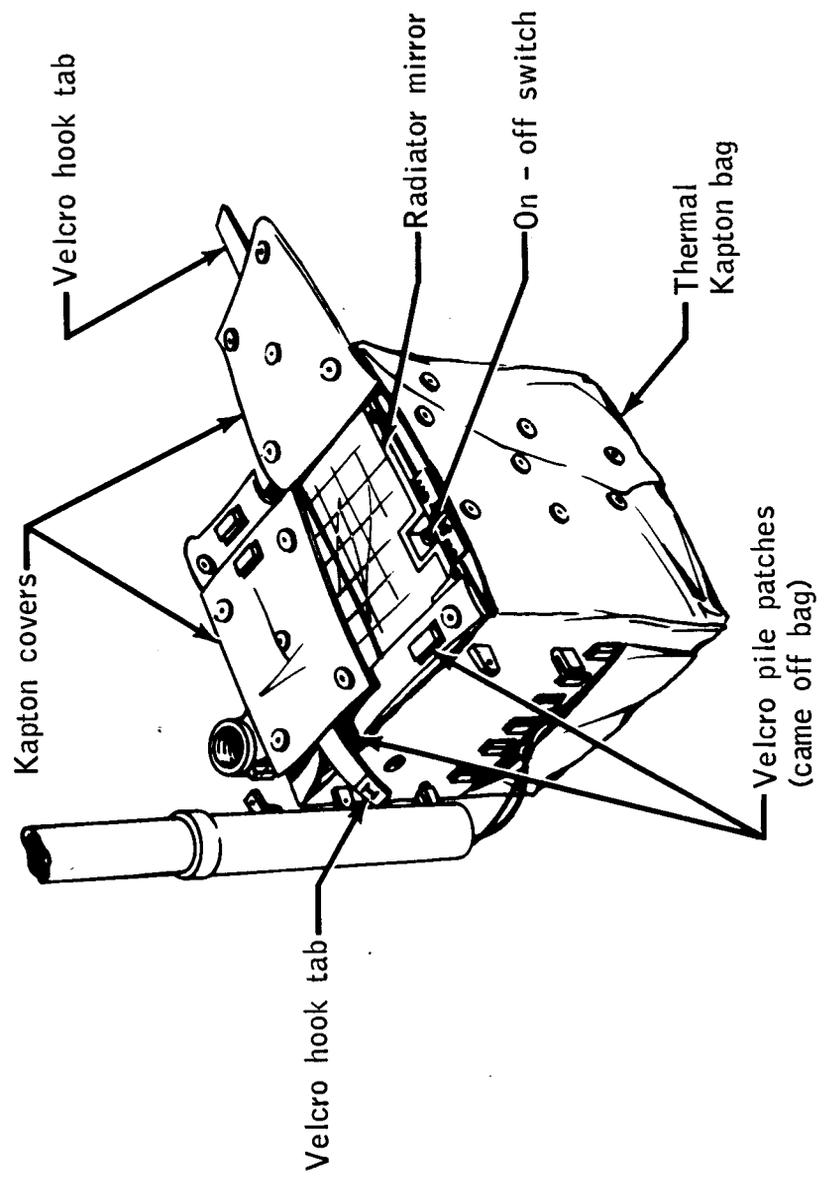
Figure 5-3-3.- Surface electrical properties experiment receiver.

The receiver was protected by a multilayered aluminized Kapton thermal bag (fig. 5-3). The thermal bag had two flaps (of the same material) which protected the optical solar reflector (mirror) on top of the receiver from lunar dust accumulation. A dust film of about 10 percent on the mirror surface could result in the indicated degradation of thermal control and a film of this amount would not normally be visible to the crew.

Cover design depended upon Velcro straps and pads to hold the Kapton flaps tightly closed to keep out dust and sunlight (fig. 5-3). The Velcro pile pad was bonded to the Kapton bag and the Velcro hook strap was bonded to the Kapton flaps. The bond of the Velcro pads for both flaps had already failed before the Lunar Module Pilot configured the receiver at the end of the first extravehicular activity, thus resulting in dust accumulation on the mirror surface under both flaps. The bond of the Velcro pads to the Kapton failed, leaving no trace of the adhesive on the Kapton, and the pads remained attached to the straps. The polyurethane FR-127 A and B bonding material specified was supposedly acceptable for bonding Velcro to Kapton.

The bonding procedures used are being investigated.
